Demonstration of a Pre-Commercial Long-Length HTS Cable System Operation in the Power Transmission Network

DOE Peer Review Update
July 27-29, 2004
Washington, DC

LIPA Project Overview

LIPA 138 kV HTS Cable Project – Phase 1

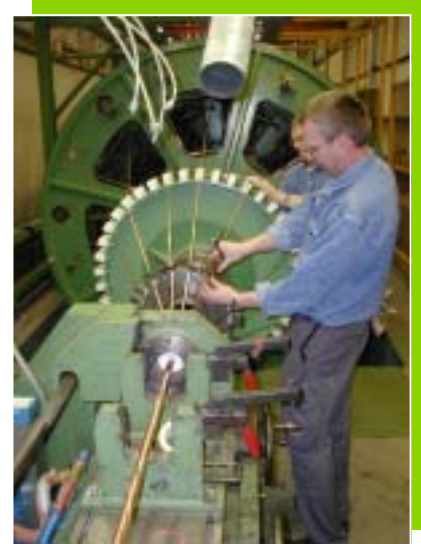
- Cable

- Modeling complete
- Preliminary design complete
- Fabrication of the first of several manufacturing “dummy” cables complete
- Data analysis underway
- Next manufacturing trial to begin in late July
- Component testing underway

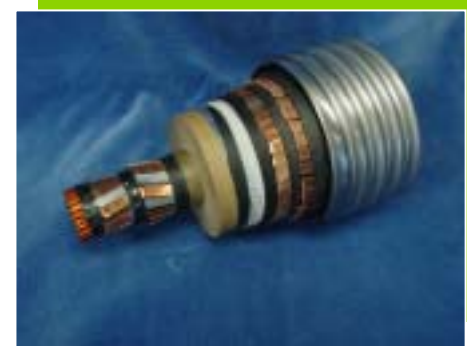
- Terminations

- Design complete
- Component testing underway to verify design
- Prototypes (2) to be built this CY

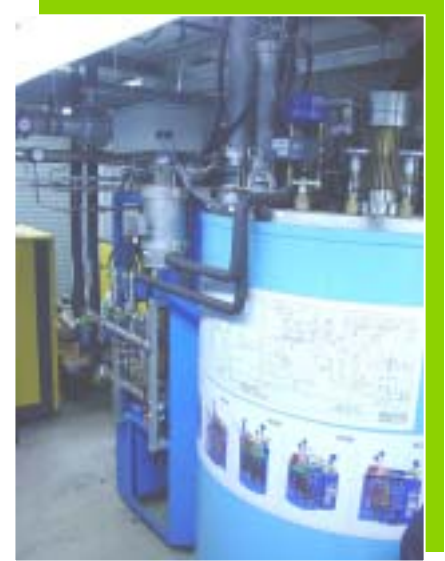
- Refrigerator

- Re-use of Detroit refrigerator from previous Pirelli SPI Cable Program
- Upgrades to system will include improved telemetry to allow for remote monitoring and control and possible capacity upgrade
- Will be operated 6 months prior to cable commissioning

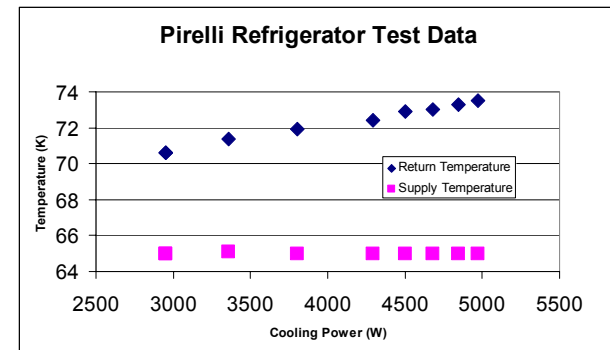
- Advanced Refrigerator Development

- High frequency pulse tube
- Optimized for efficiency and temperature
- Integrated into cooling system as “non-critical” cooling
